Report from a UK incident

Incident involving 'premature lock out' on Techops 660 Gamma Radiography Source Projector

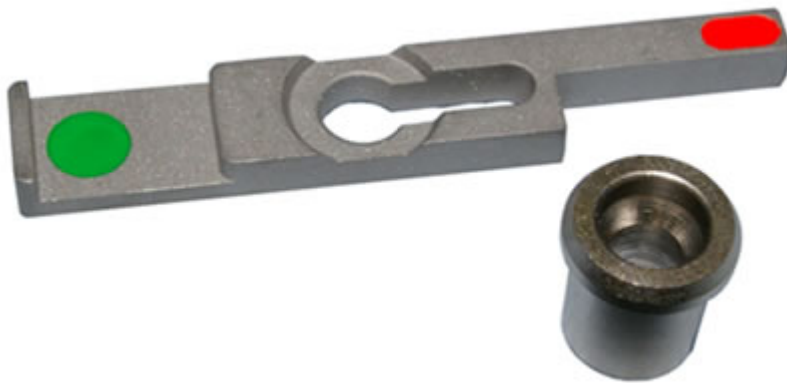
- The later version of the source container (the "880") has a modified slide lock slide assembly to prevent the possibility of premature lock out; this has been achieved by redesigning the lock slide and central sleeve to incorporate a chamfered location in the lock slide and a corresponding machining on the central sleeve so that the Pozilock will only lock in the correct position. (Please note, these parts are not interchangeable with the 660.). This is illustrated in the diagrams below.

The lock slide and central sleeve showing the chamfered edges of the corresponding components to ensure positive location.

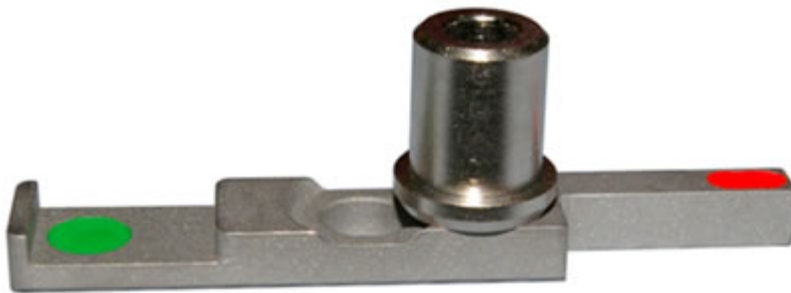
In this position, you can see how the lock slide slides across the front face of the central collar
