Report from a UK incident

Contractor exposed to radiation during level gauge refurbishment

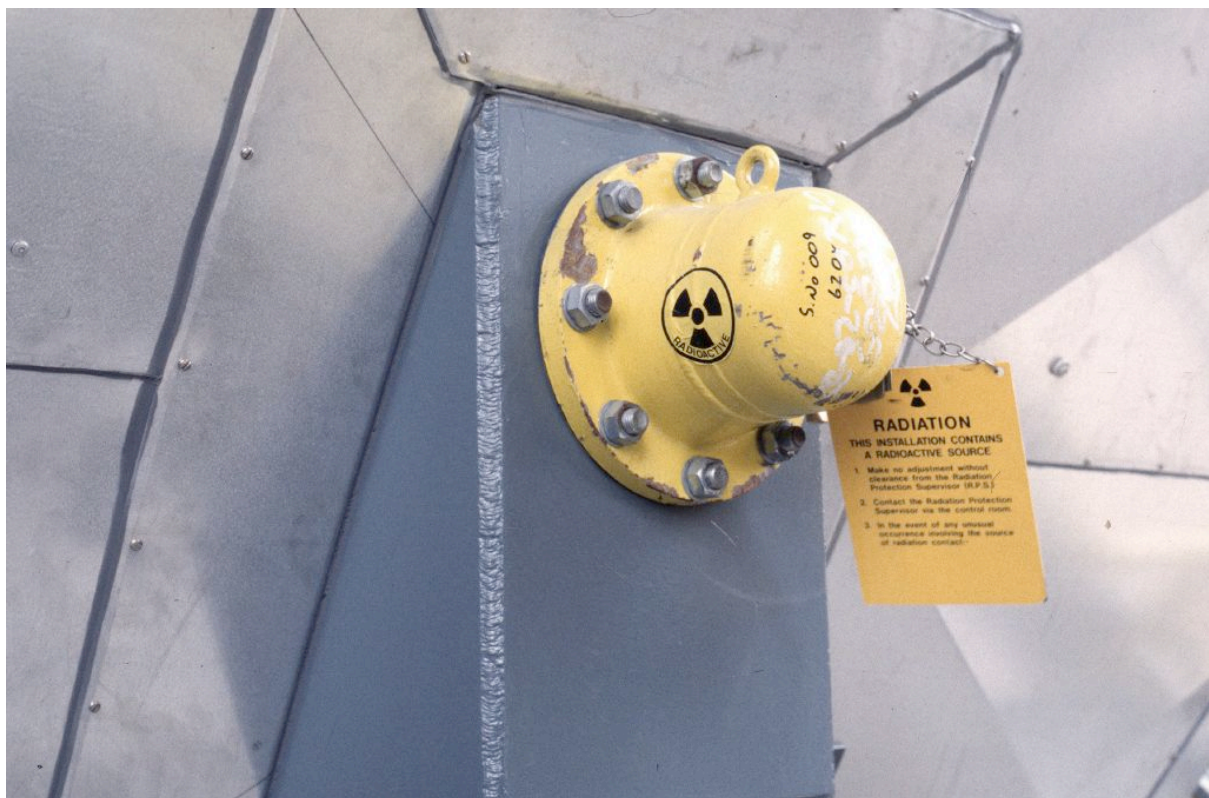
A typical caesium-137 level gauge in position
